WASHINGTON SERVICE QUALITY REVIEW

January 1 – December 31, 2020 Annual Report

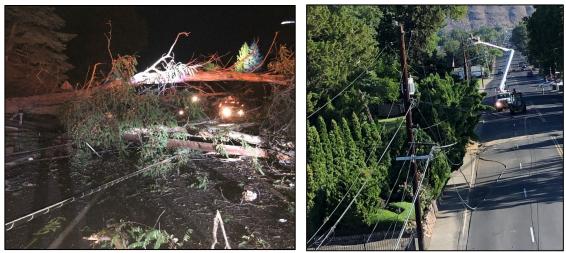
Figure 1. Photos of damaged equipment from downed tree.

At 10:53 p.m. a large street tree fell. As it fell it damaged a pole, line, and related distribution equipment along seven spans of the circuit. The damaged equipment included heavy stranded mainline feeder, poles, cross-arms, transformers, and a gang switch that serves as a tie point to adjacent circuits (used as an isolation point to step restore customers from the breaker to the switch). Crews were quickly dispatched to the location to assess the damage; they determined

that their options for stage restoration had been compromised by the tree's damage of the feeder tie and switch, but that if they prioritized that repair they could quickly restore power to a large number of customers.

Repairing the feeder tie involved resetting downed twisted conductor and repairing the switch, after which crews were able to perform the first step restoration, restoring 1,686 customers in 11 hours 59 minutes. During the second stage of repairs crews worked to replace the damaged pole, cross-arms, insulators and reinstall conductor, with the final restoration stage occurring, restoring the remaining 503 customer in 15 hours 14 minutes.

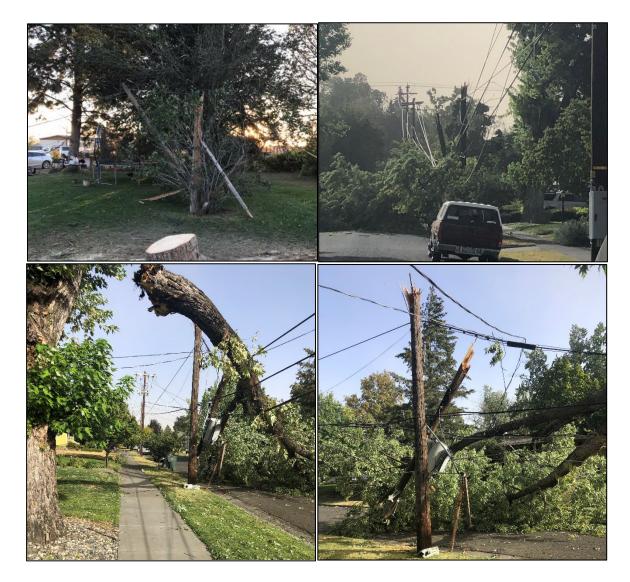
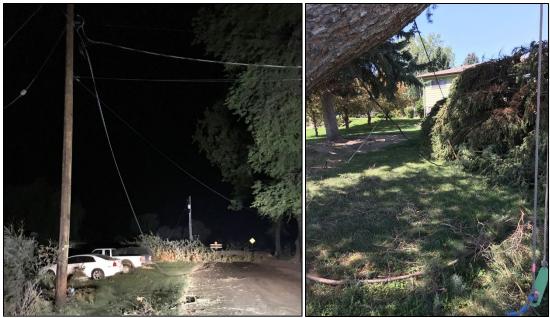
Complications arose pinpointing specific damage locations due to the tendency for certain locations to mask subordinate outage events, which challenged restoration efficiency and

Photos of damaged equipment from downed trees.
