WASHINGTON SERVICE QUALITY REVIEW

January 1 – December 31, 2020 Annual Report

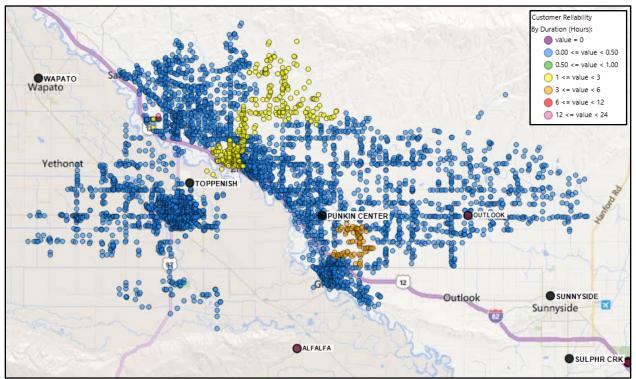
Figure 1: Outages experienced during the major event by duration.

At 5:37 a.m. on March 14, 2020 Sunnyside, Washington, experienced a SAIFI-based major event when 42% of its served customers experienced an outage lasting 6 minutes. In the early morning of March 14th, during high wind, snow/sleet/rain and cold temperatures, a transformer low oil alarm precipitated immediate correction by local substation crews. While they were performing this corrective maintenance the substation circuit switcher and circuit breakers operated, de-energizing feeds to the Toppenish and Punkin Center Substations. These two distribution substations feed a total of nine circuits, serving approximately 10,300 customers. The crew quickly remediated the situation and at 5:43 a.m. power was restored back to the two distribution substations, re-energizing power to the customers.

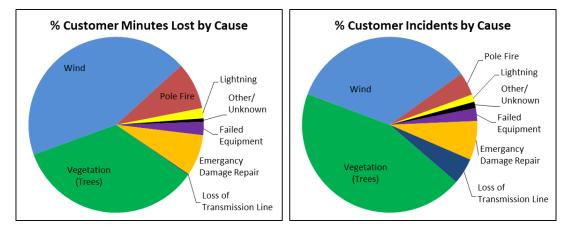
Figure 4. Percent of customer Minutes lost and % of customer incidents experienced by cause.

The magnitude and severity of the storm during its initial onset coupled with the large number of outage events and affected customers, as described above, became a large task for crews in the region, which typically experience an average of only 2-3 outages a day. In addition the storm greatly affected the region as a whole causing a major event in Oregon, slowing the ability to bring in outside crews to assist in the restoration process. Internal crews from Walla Walla and Portland were brought in, along with several internal out of area single responders and 11 full contract crews were brought in. All crews in Yakima were used as responders for the duration of this event as well as many out of district two man crews, this allowed the local crews familiar with the area to feed the 13 crews repair work and keep in front of their need for next jobs. Figure 4 below represents the percent of customer minutes lost and the number of customer interruptions by cause for the duration of the event. The most impactful outages were the result of wind and vegetation which account for 78% of the total customer minutes lost and 78% of all the customer interruptions. Pole fires also contributed to a significant amount of outages, while emergency damage repair outages resulted from steps required to safely make repairs to equipment initially damaged by effects of the storm. Repairs to equipment consisted of replacing broken poles, removing trees from lines, replacing transformers, responding to damaged service transformers and containment, clearing damaged trees and limbs that were not fully down but posed hazards, and reinstalling damaged conductor.

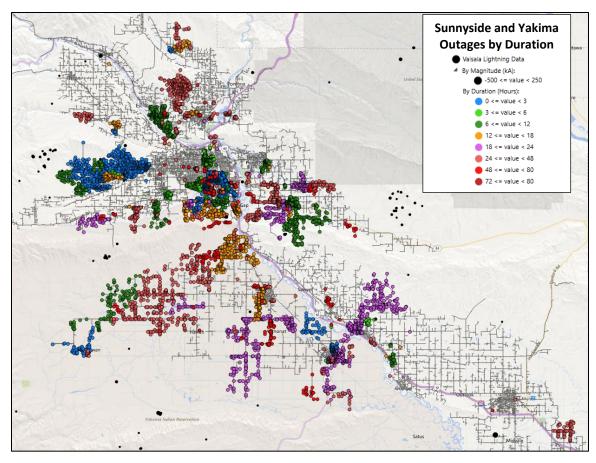
Figure 5. Sunnyside and Yakima, Outage Duration by hour and lightning strikes.

Approximately 23,750 customer interruptions were experienced, some of which were experienced by the same customers over the duration of the storm, see figures 5 and 6 below. The number of concurrent outages during the event peaked at 163 outages on the 30th at 10:54 p.m., with the number of open outages remaining above 100 for 46 hours. Sustained outage durations ranged from 7 minutes to 3 days 6 hours 14 minutes, with an average cumulative outage duration of 12 hours 2 minutes.

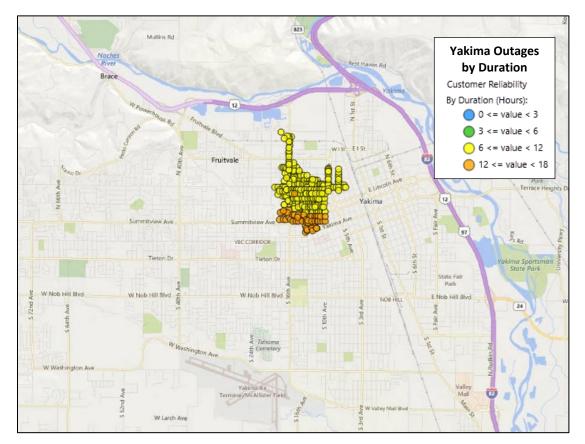
Figure 3. Yakima Outage Duration by hour.

At 10:53 p.m. a large street tree fell. As it fell it damaged a pole, line, and related distribution equipment along seven spans of the circuit. The damaged equipment included heavy stranded mainline feeder, poles, cross-arms, transformers, and a gang switch that serves as a tie point to adjacent circuits (used as an isolation point to step restore customers from the breaker to the switch). Crews were quickly dispatched to the location to assess the damage; they determined

Repairing the feeder tie involved resetting downed twisted conductor and repairing the switch, after which crews were able to perform the first step restoration, restoring 1,686 customers in 11 hours 59 minutes. During the second stage of repairs crews worked to replace the damaged pole, cross-arms, insulators and reinstall conductor, with the final restoration stage occurring, restoring the remaining 503 customer in 15 hours 14 minutes.

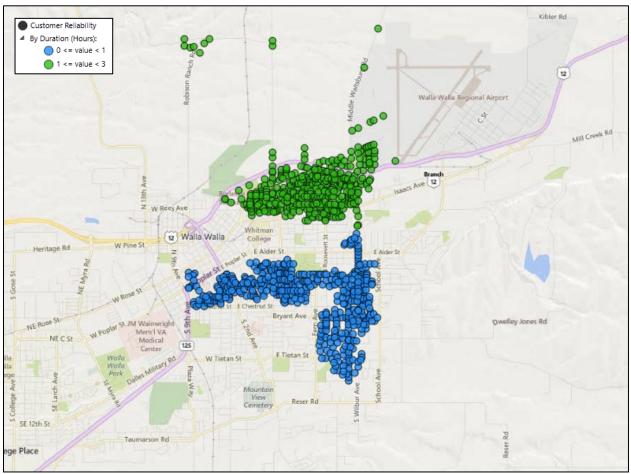
Figure 1: Loss of Substation outages experienced during the major event by duration.

At 7:35 a.m. on August 20, 2020, Walla Walla, Washington, experienced a SAIFI-based major event when 16% of its served customers experienced an outage due to a loss of substation. Crews were quickly dispatched to the location where they found a squirrel had made contact with an energized 12.5 kV bus and ground on a circuit breaker at Mill Creek substation. This resulted in a catastrophic failure of the circuit breaker causing an outage to 2,057 customers fed from circuit 5W116. In addition, the 69 kV power fuses protecting the transformer operated (believed to have been due to the transient voltage that evolved during the fault clearing), resulting in the de-energization of circuit 5W127, which serves 2,535 customers.

remaining 2,057 customers within 2 hours 15 minutes. Figure 1 below shows the customers affected by the loss of substation event and the relative outage duration.

Crews were able to transfer circuit 5W127 to the other station transformer in the substation that was not electrically connected to the blown power fuses, restoring service to 2,535 customers within 51 minutes. In order to restore service to the remaining feeder the transformer power fuses needed to be replaced and the bus tie breaker was reconfigured to carry customer load. Personnel were able to complete this task and restore power to the
